Manhole Inspection Summary

Manhole # S13OO1001MH

Location Address: **2707 RUSCOMBE**

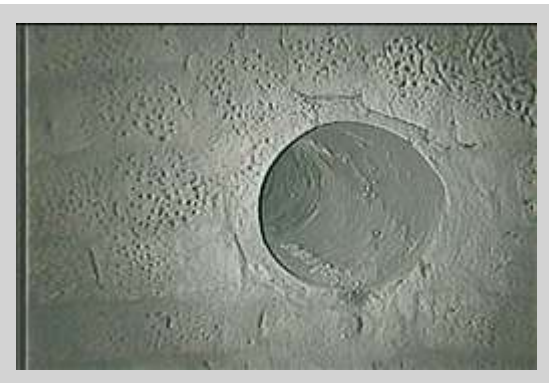
8 in. Circular Gravity Sewer Pipe In @ 7 O'Clock

Deposits: ☒ **None** ☐ Mud ☐ Sludge ☐ Debris ☐ Grease

Infiltration: **None** Pipe Seal Cond: **Unknown**

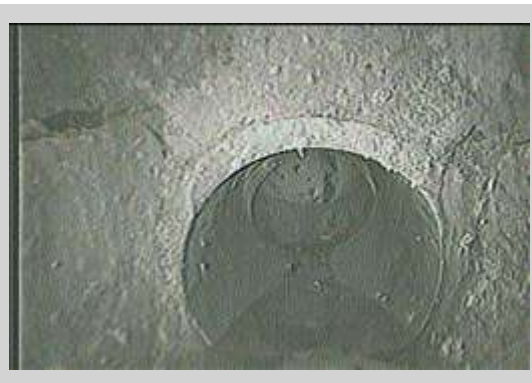
Drop In @ 7 O'Clock

Drop: **Outside** Rod and Bar

Angled: **Yes** Reading: **9.50** (ft.)

Drop Condition: **Open**
